## Update on Fire Risk assessment

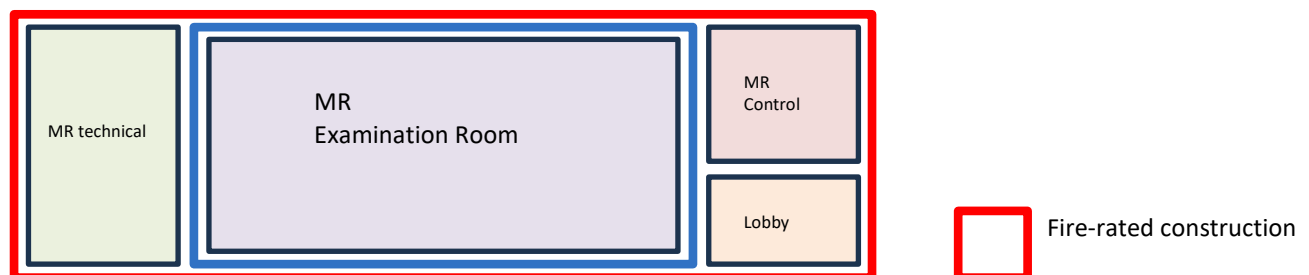
These cables form part of the medical device and its certification. Addition of extra firestopping materials in effect represents a modification of the device outside of its certification. Due to the complexity of the interconnections between the examination room, technical room and control room, these should be within the same fire protection zone, and firestopping would be unnecessary between these rooms.

*Example layout illustrating location of fire barriers enclosing the combination of MR examination room, technical room and control room.*
